SCI builds an **MGA TWIN CAM** for competition *by John Christy*

*The potential was there —
all it needed was coaxing.
Here is how it was done.*

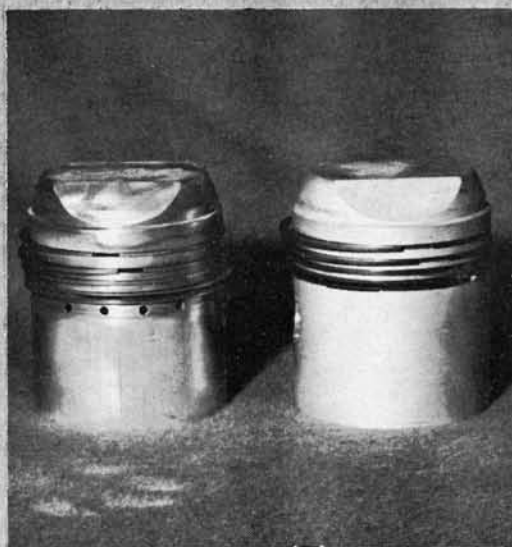
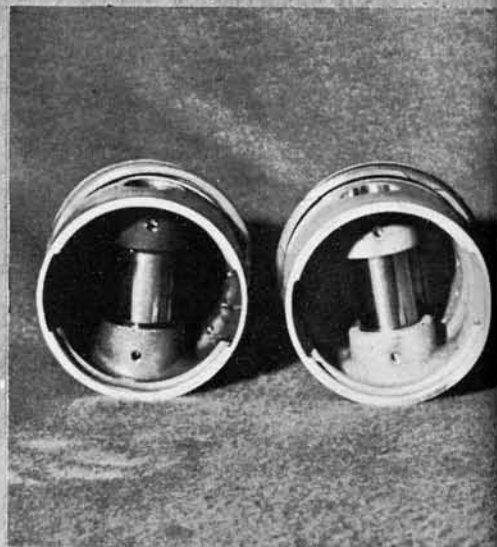
*LEFT — New type of piston is seen at right. Rings are closer together and there are no vent holes visible. In the SCI MG the top chrome ring was replaced with an iron ring similar to second and third units.
RIGHT — Pins are palm-push fit at room temperature. Large ridges visible can be cut for balance.*

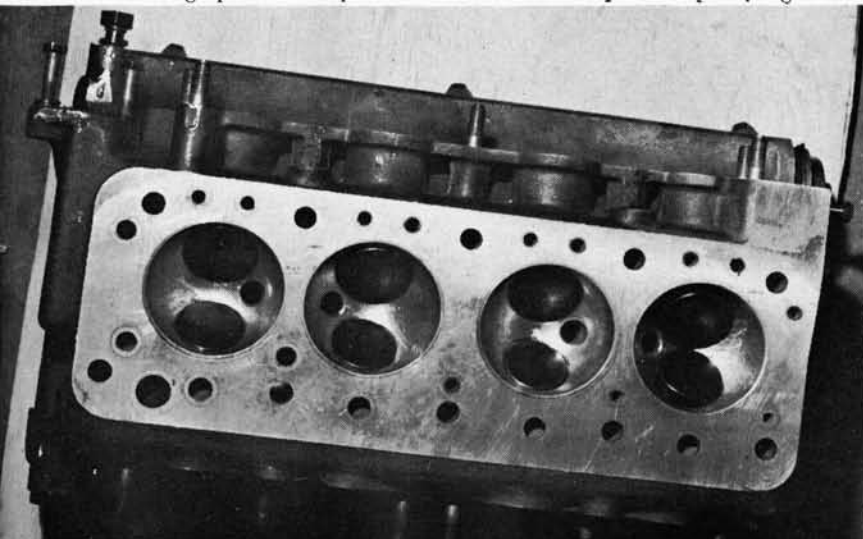
Combustion chambers were relieved of all sharp edges left in production machining operations. Special attention must be paid to sparkplug holes.

Other than the port matching and cleaning the major work in the head is the relief of hot spots in the form of sharp edges left by machining and doming operations. The major source of trouble and the one that probably caused the running-on and preignition in our engine was the sparkplug area. Apparently the dome cutting was done after the plug inlet was drilled and threaded and the resulting knife edges made ideal glow points. Such faults as these are not necessarily the private property of MG Twin Cams but are found in many other marques as well and cause much of the running-on character that is usually associated with four cylinder engines tending to cause the mistaken impression that running on and preignition is one of the characteristics of the four-barrel. All such edges and the edges of the combustion chamber as well were rounded off in our Twin Cam. Where it once dinged, pinged and chugged on with the switch off it now runs smoothly and quietly under load and shuts off instantly with the key. Combustion now takes place when the sparkplug tells it to and not when the fuel and air are shoved up against some evilly glowing piece of metal.

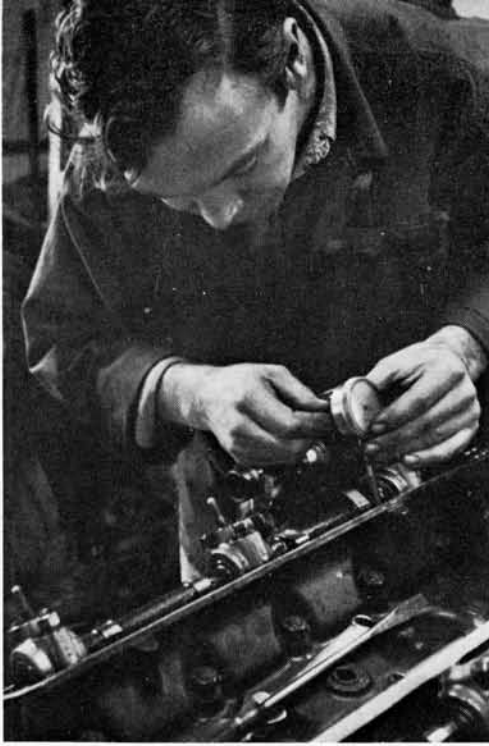
But back to the valve check-out. Correct valve clearances are specified as .018 to .019 of an inch. The clearances on this particular pilot model were from .016 on

one valve to .021 on another and all points in between for the rest. The cam timing also gave a clue to why we hadn't been getting the power we had expected. The intake cam checked out at four degrees late and the exhaust cam proved to be seven degrees early. In other words the intake valves were opening and closing later in the cycle and the exhaust valves were operating much too soon. The net result was that most of the fire was going out the exhaust instead of pushing the pistons down like it should.

LEFT — Joe Virag checks out the valves with a dial indicator prior to disassembly of the engine. All timing was carefully checked during dismantling and assembly. ABOVE — Ports on exhaust side are huge and virtually straight through. No enlargement necessary but all ports were matched to manifolds and equalized in size.

Lesson number two. If you have one of the early series Twin Cam units and are not getting the wallop you should, set the cams by use of a degree wheel and depending on the camshaft numbers use the following figures:

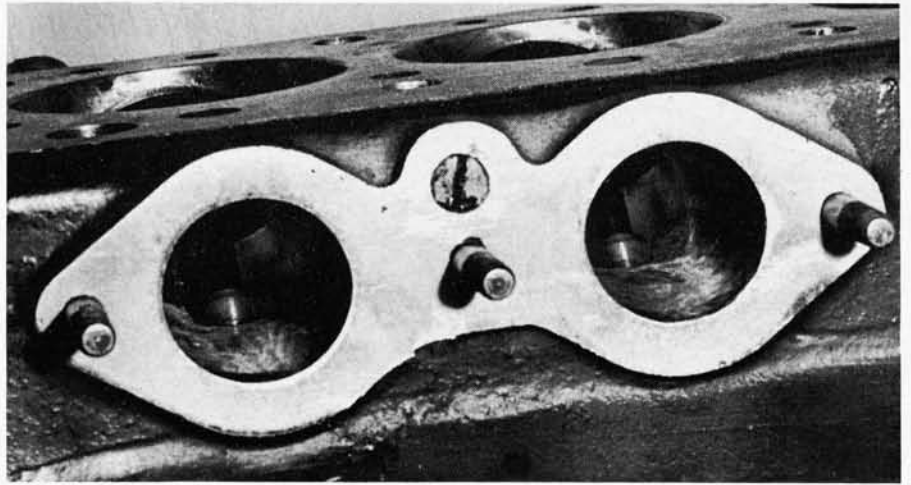
passages. When bolted to the head for checking it was found that the outlets at the mating surface were offset downward in relation to the inlet ports in the head so the ports were scribed and tapered to a perfect match. On other engines this offset could be up, down, right or left or even non-existent in some cases. In these cases not too much worry need result but if the offset is downward as in our case there is a problem since there is not too much metal in the bottom lip of the port. The angularity of the taper must be watched and controlled to avoid weakening this lower lip. The ports in the Twin Cam need not and should not be enlarged but they must be cleaned and matched one against the other. Some attempt at equalization is made at the factory but the speed of production line prevents really accurate port equalizing. The result is that in the non-machined portions no two ports are exactly alike as they should be if the potential inherent in the MG is to be realized.

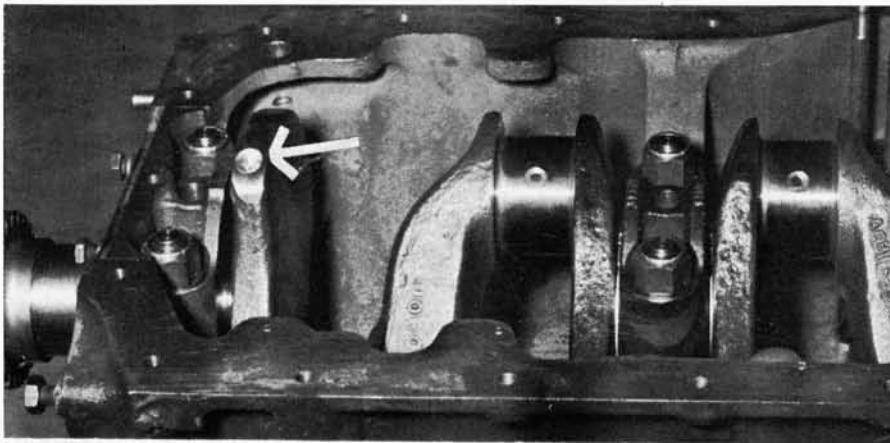
BELOW — Dynamic balance tests of the sturdy crankshaft showed only one small balance drilling was needed (arrow). The same applied to flywheel and clutch. RIGHT — Short stiff rods are similar to those in Stage 4 MGA fitted with solid skirt pistons. Large bosses on caps and little end may be ground for balance.

Each rod, piston and the bearings to go with that particular rod were carefully weighed and balanced against each other. The weights were marked down and the crank, flywheel and new clutch assembly were sent out for dynamic balancing. Only one small balance hole had to be drilled in each item but they *did* need the drilling. This balancing comes easy on the Twin Cam — or any MGA for that matter. The rods have large, meaty sections at the lower end of the caps and on the little ends so they can be slightly ground to gain the necessary end-for-end and overall balance. The pistons also have internal ridges at the bottom of the skirts from which metal can be carved if found necessary. In all cases it is vital that the bearings to be used in the final assembly be clamped in the rods when the weighing is done. It is also a good idea at this point to tamp the locating tang on each bearing shell into its recess in the rod big-end. These are *not* full floating bearings and must be well and securely located. The rods in the Twin Cam are virtually the same as the Stage Four rods for the MGA in that the wrist pins are of the full floating, push-fit type rather than the clamped pins found in the standard MGA and other B-Type engine units. These wrist-pins should be (and were in our case) an easy palm-push fit in both the rod and the piston at about 70 degree temperature, Fahrenheit. Location is by circlips in the piston at either end of the pin.
