SCI builds an **MGA TWIN CAM** for competition *by John Christy*

*The potential was there —
all it needed was coaxing.
Here is how it was done.*

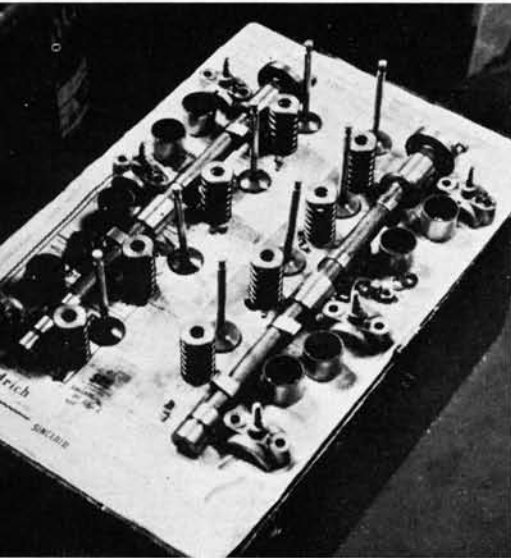
Valve, cam assembly broken down and laid out with all components separated.

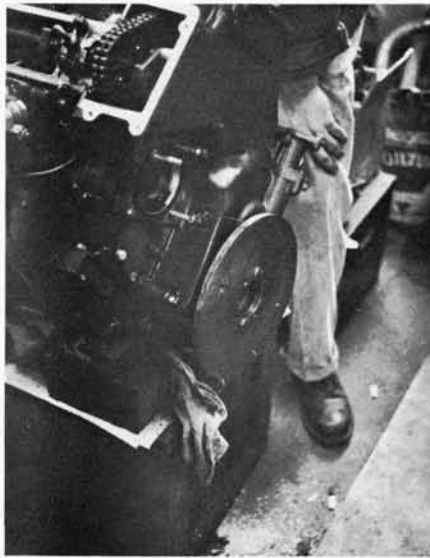
one valve to .021 on another and all points in between for the rest. The cam timing also gave a clue to why we hadn't been getting the power we had expected. The intake cam checked out at four degrees late and the exhaust cam proved to be seven degrees early. In other words the intake valves were opening and closing later in the cycle and the exhaust valves were operating much too soon. The net result was that most of the fire was going out the exhaust instead of pushing the pistons down like it should.

A degree wheel is a must if accurate valve timing is to be achieved on MG.

Lesson number two. If you have one of the early series Twin Cam units and are not getting the wallop you should, set the cams by use of a degree wheel and depending on the camshaft numbers use the following figures:

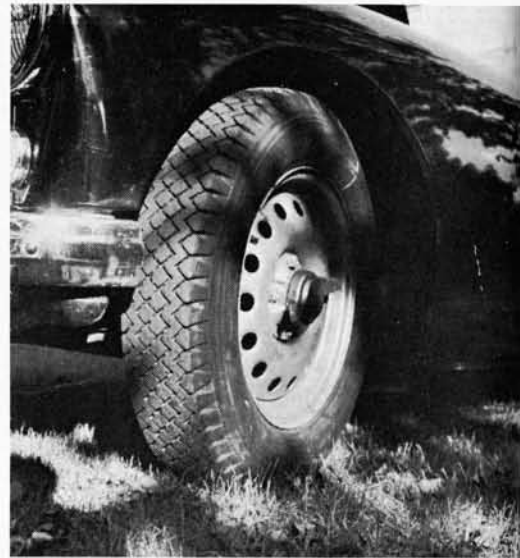
Dunlop racing tires accounted for almost a full second lap-time in tests.
